Honeywell FC37A Cell Repair

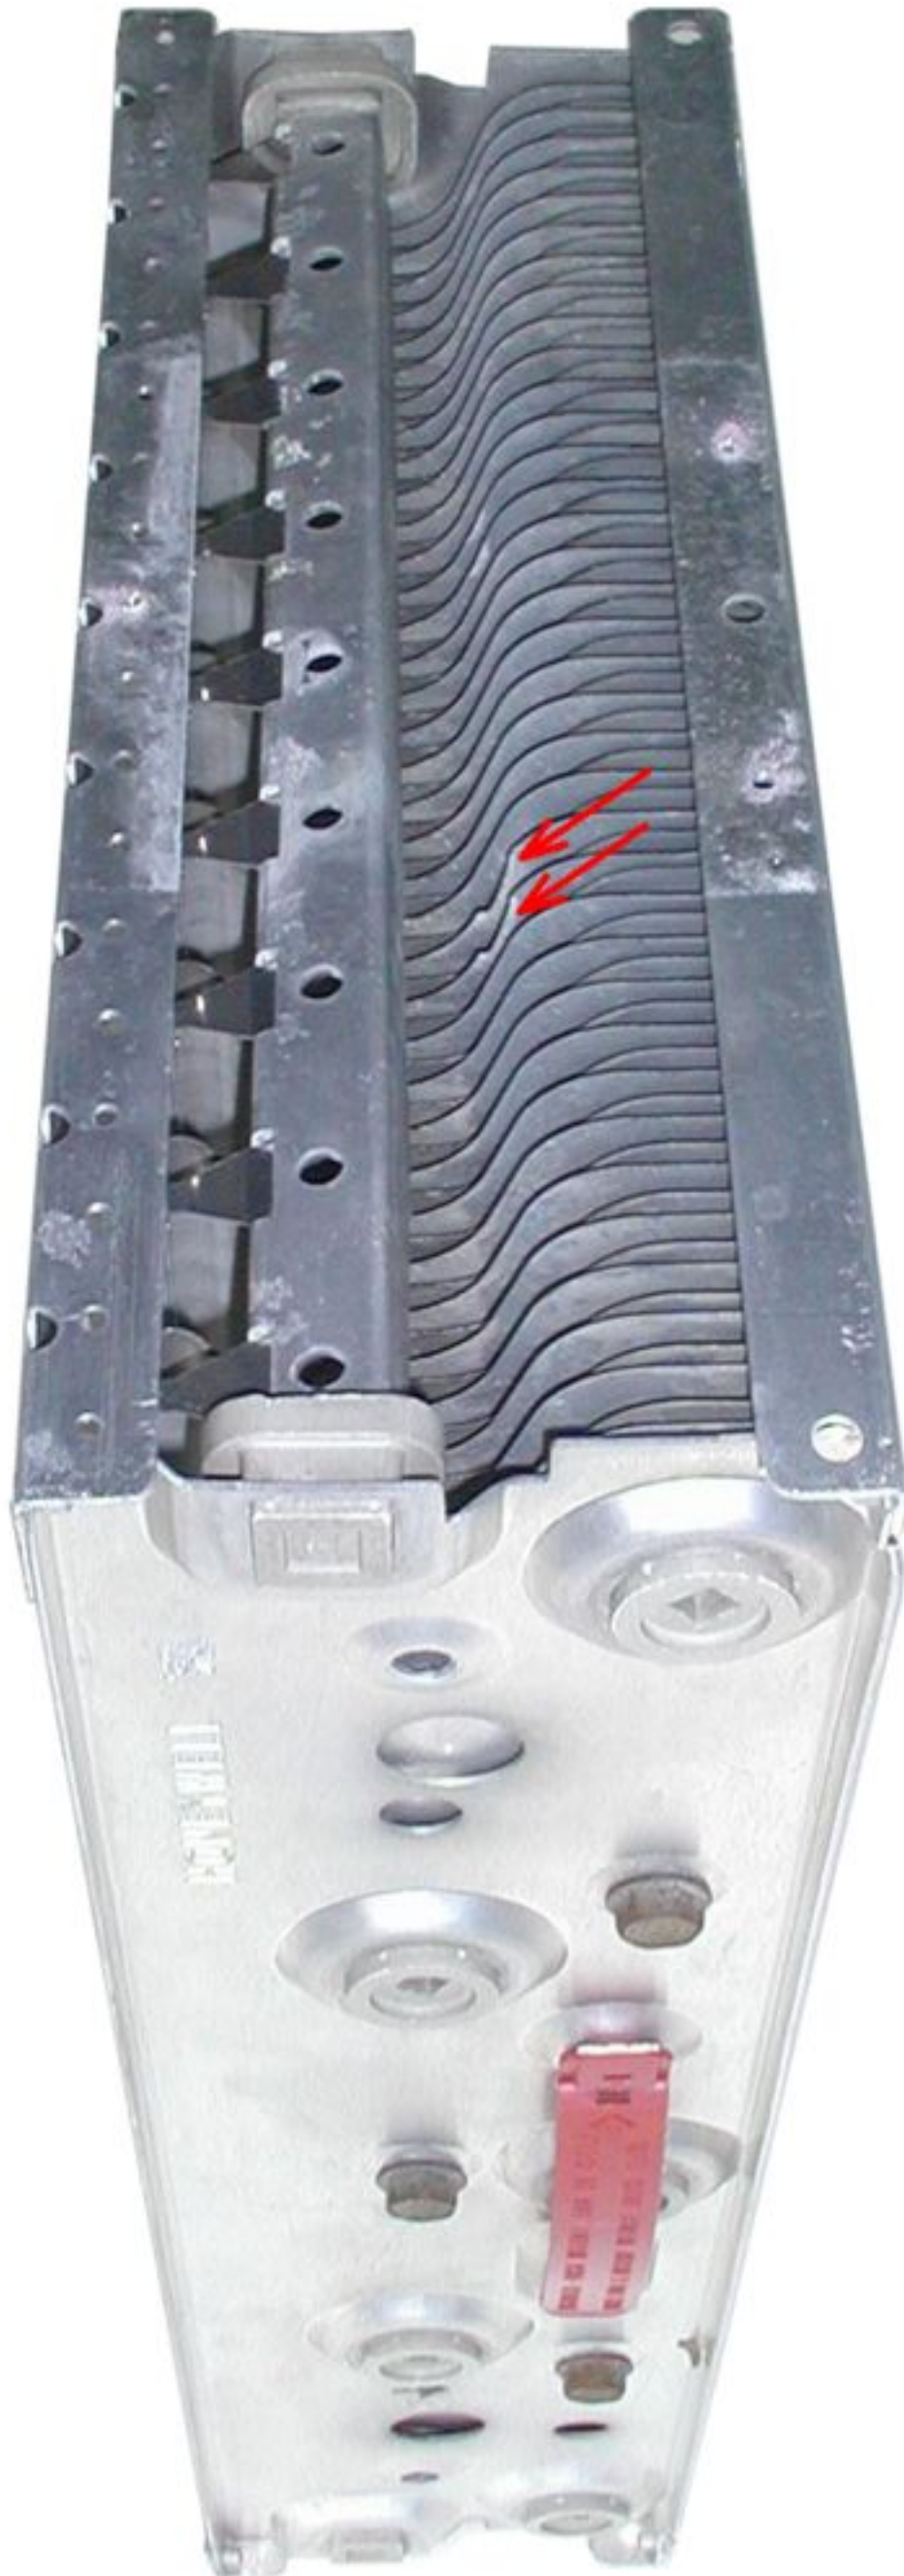
Here the contact pad has been removed (the rivets drilled out). The contact makes contact with the edge of every other cell plate. The contact energizes every other cell plate to 4 kvdc. The alternate cell plates are chassis grounded. If the edges of the plates burn down far enough, the contact will short against every plate and not every other. In the early stage it would be a source of arcing.
